INVESTIGATION OF THE WEAR AND FAILURE MODES OF SURFACE ENGINEERED MULTIPOINT CUTTING TOOLS.

A thesis
submitted for the fulfilment
of the requirements
for the degree of

Master of Engineering
at Dublin City University.

Martin G. Fleming B Sc.
Department of Mechanical and Manufacturing Engineering.

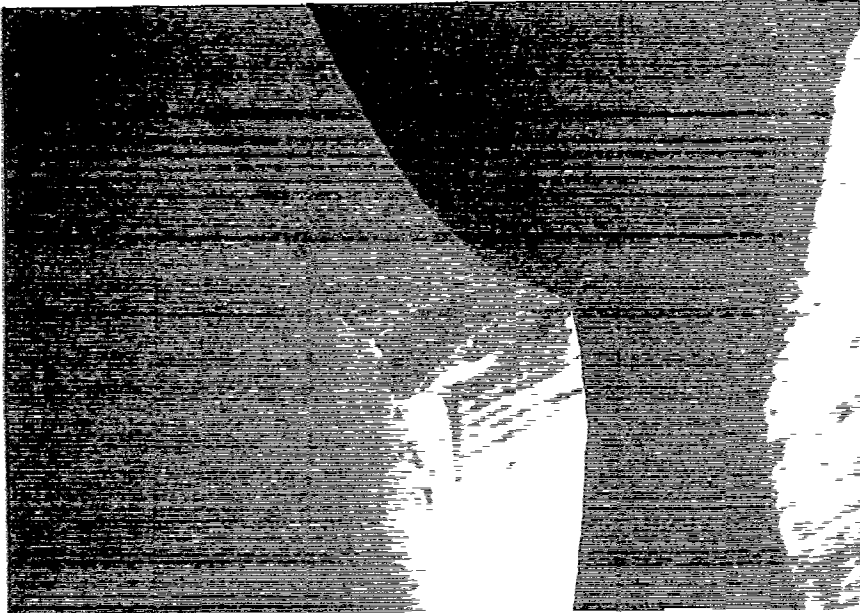
Figure 3.1

SEM image of an untested bandsaw tooth displaying a transverse gouge consistent with a defect induced by tooth milling.

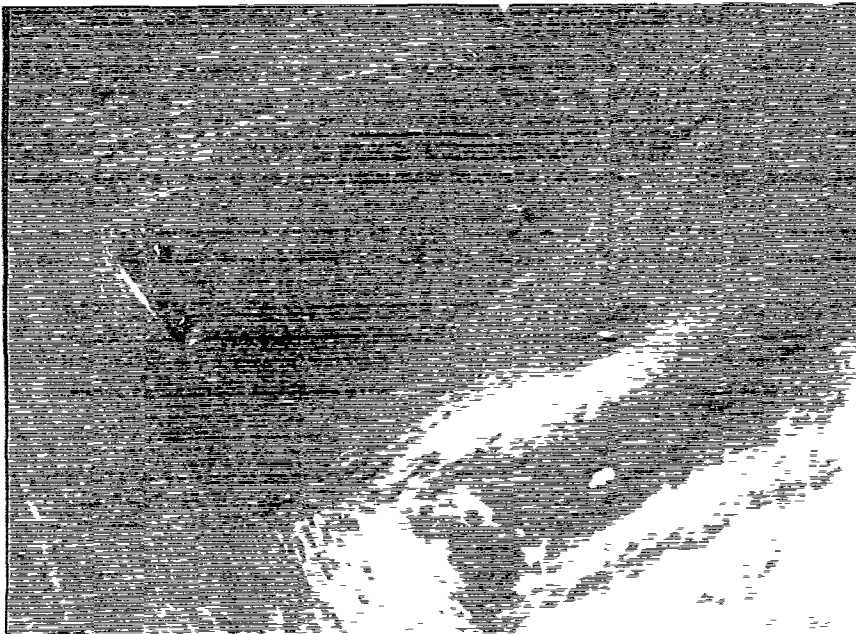
Figure 3.2

Detailed SEM image of the bandsaw tooth detailed above displaying a microvoided surface consistent with ductile overload.

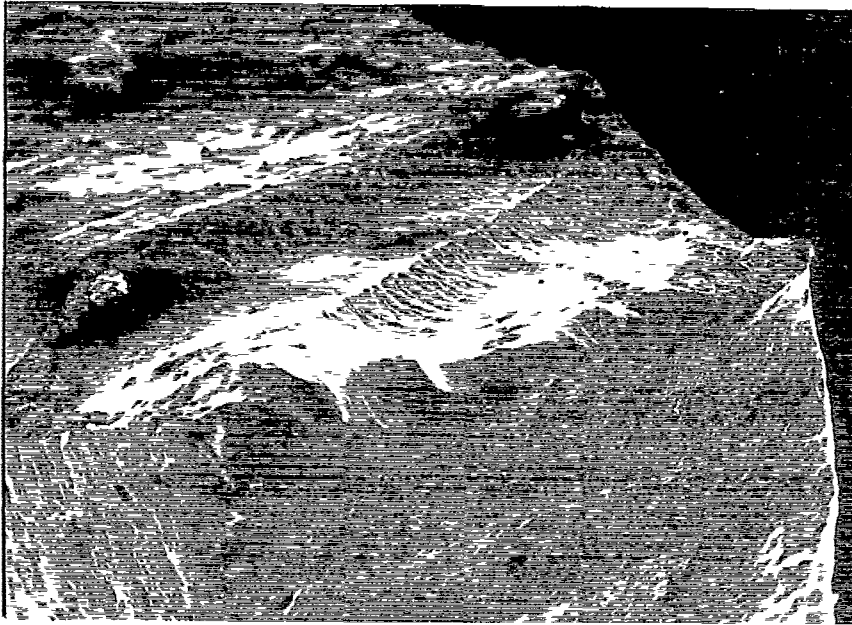
Figure 3.4

Detailed SEM image of an unused bandsaw tooth displaying lack of uniform tip sharpness resulting from tip fracture during milling.

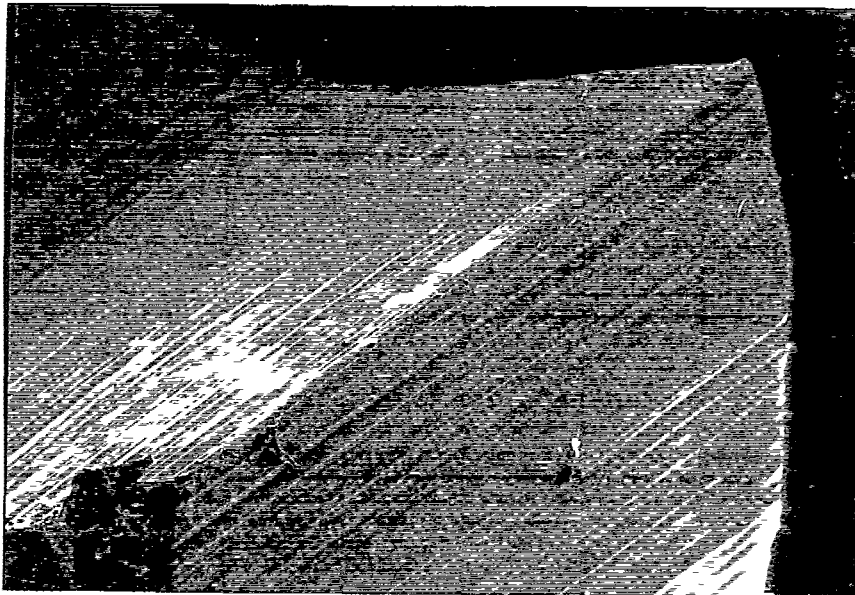
Figure 3.5

SEM image of an unused circular saw finisher tooth detailing damage due to handling, surface debris and a general rough ground appearance.

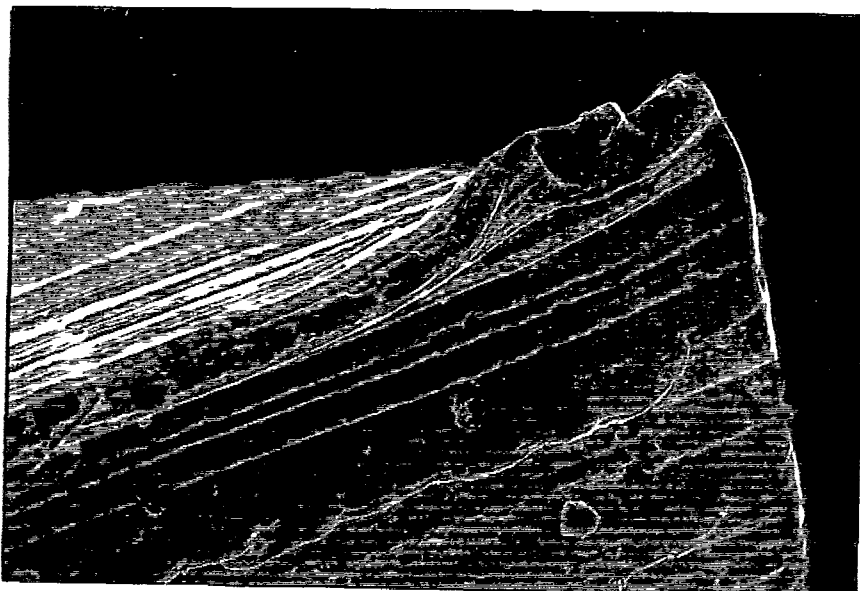
Figure 3.6

Detailed SEM image of the finisher tooth detailed in Figure 3.5 above revealing a tooth tip burr and general tool surface quality.

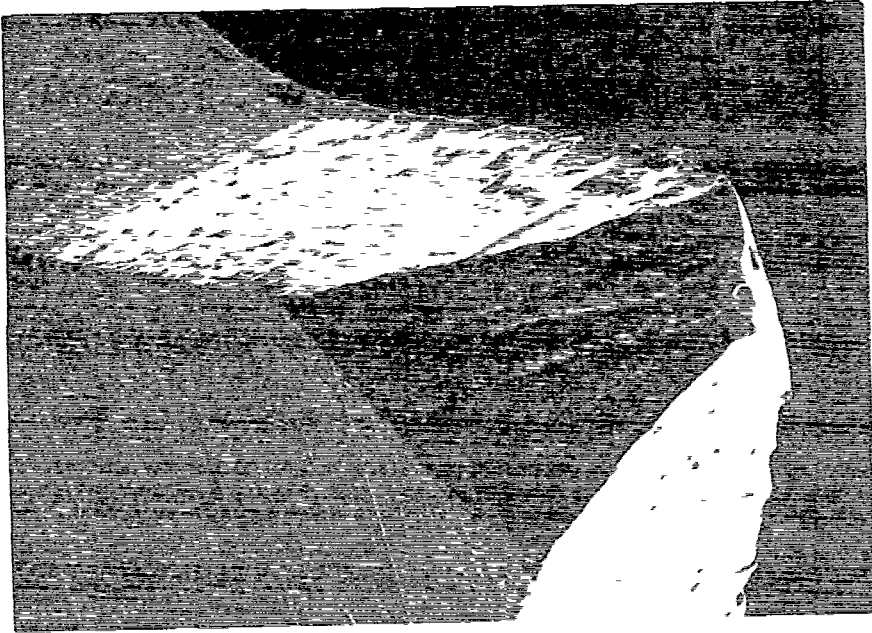
Figure 3.7

SEM image of a wear tested bandsaw set tooth displaying preferential side tip tooth fracture and wear.

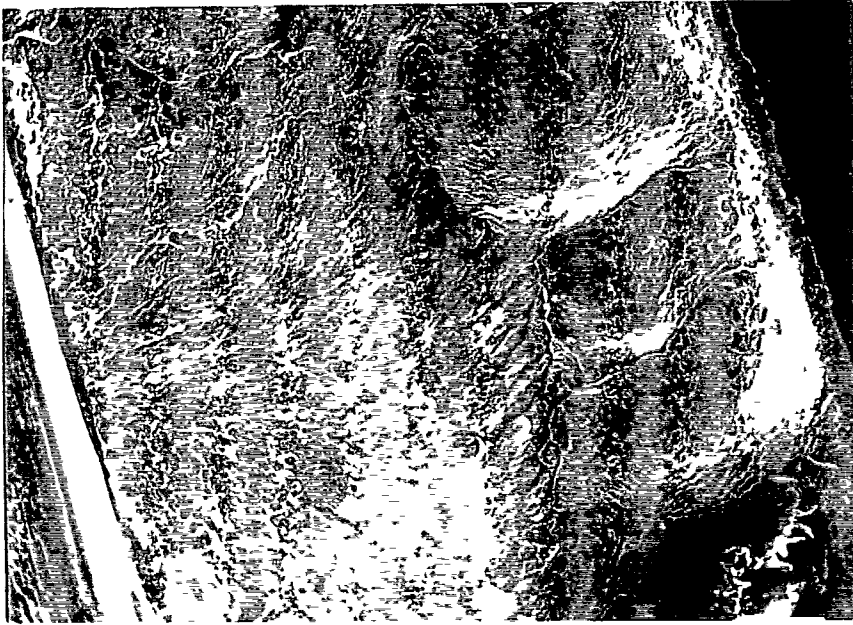
Figure 3.10

SEM image of the crack initiation point detailed in Figure 3.9, identified by a series of shallow ridges.

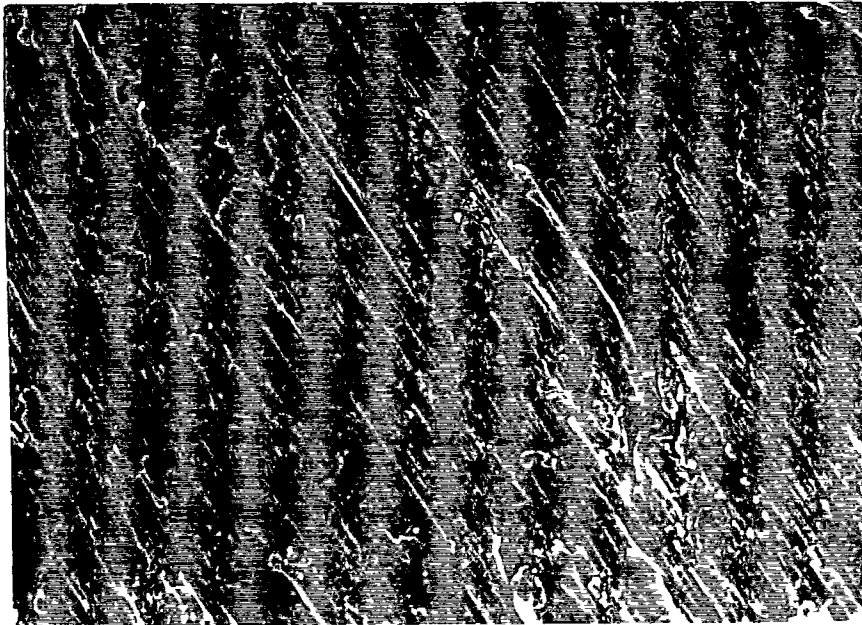
Figure 3.11

Detailed SEM image of a severe wear tested (110 m/min) bandsaw detailing abrasive and adhesive wear.

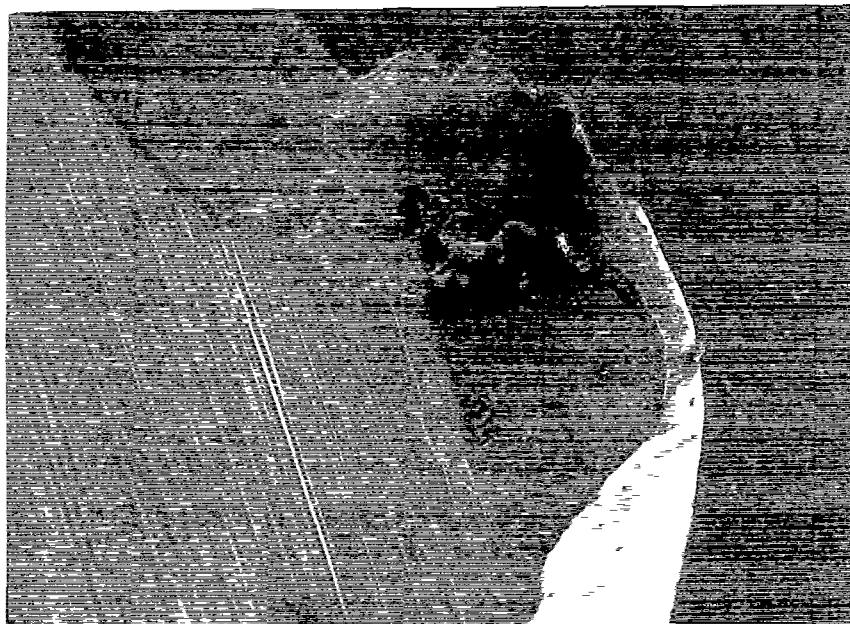
Figure 3.14

SEM image of a severe wear tested bandsaw displaying gross tooth tip plastic deformation and wear.

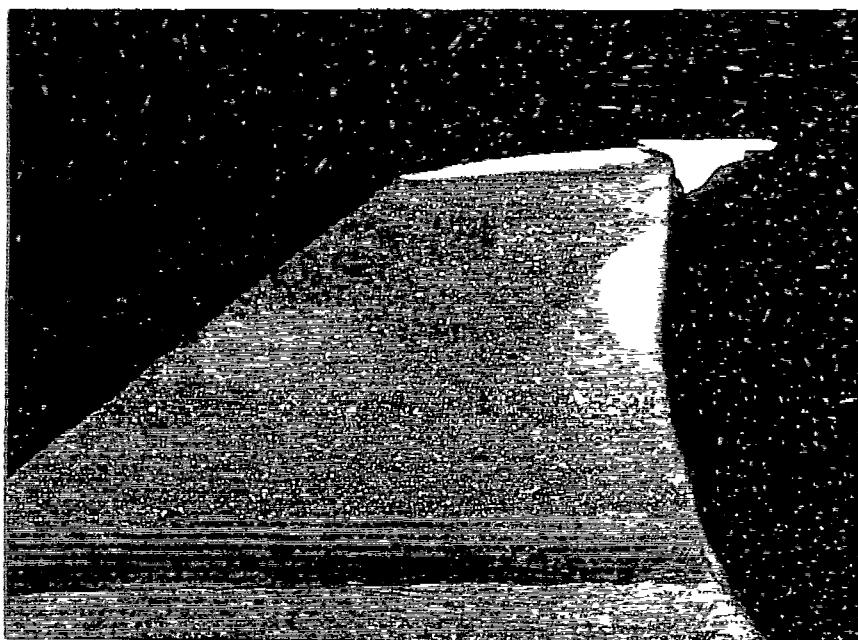
Figure 3.15

Photomicrograph of the plastic deformation processes detailed in Figure 3.14 revealing a white (unetched) layer indicative of reaustenitisation of the HSS.

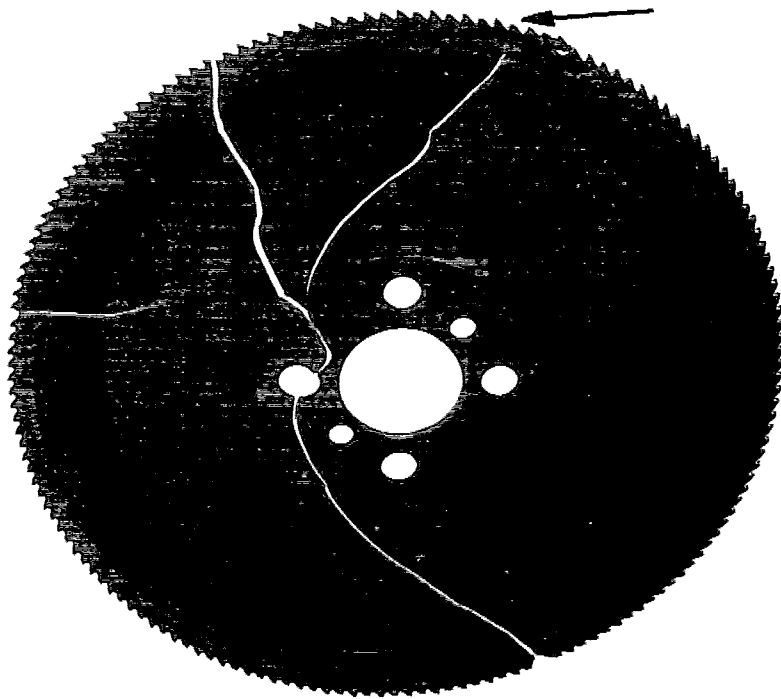
Figure 3.16

Saw No.1 (Figure 3.16) had failed during testing due to excess feed (0.045) after only cutting an area of 0.068 m². The saw failure initiation point displayed a cleavage morphology consistent with rapid brittle failure. The dominant tool wear mechanisms were abrasive and adhesive, characterised by fine

Overview photograph of circular saw No. 1 detailing the nature of the blade failure and the fracture initiation point.

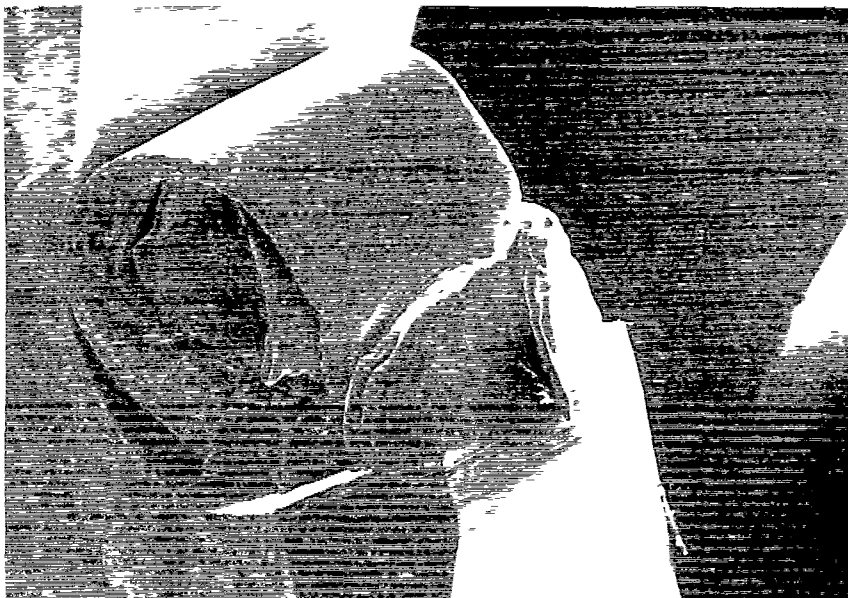
Figure 3.18

Detailed SEM of a circular saw rougher tooth tip displaying rougher tooth gullet clogging.

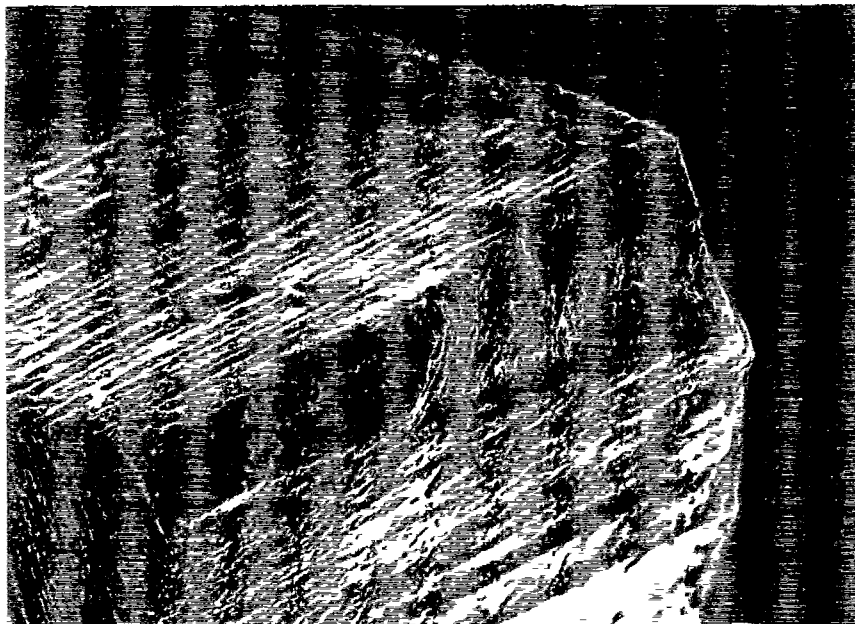
Figure 3.26

SEM image of a wear tested (59 m/min) bandsaw single tooth specimen detailing tooth chippage, abrasive and adhesive wear.
