INVESTIGATION OF THE WEAR AND FAILURE MODES OF SURFACE ENGINEERED MULTIPOINT CUTTING TOOLS.

A thesis
submitted for the fulfilment
of the requirements
for the degree of

Master of Engineering
at Dublin City University.

Martin G. Fleming B Sc.
Department of Mechanical and Manufacturing Engineering.

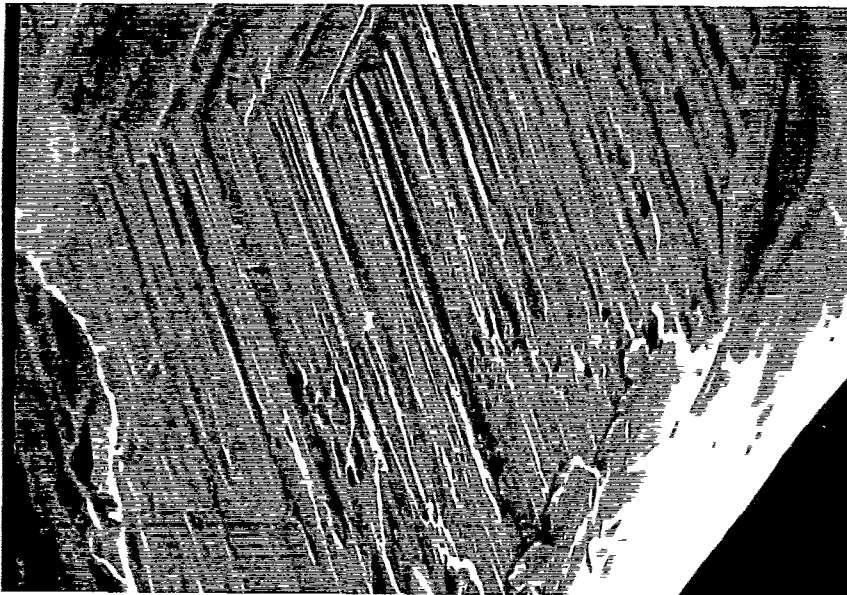
Figure 3.17

The tool wear was noted to accentuate with the increase in cutting speed (Saw Nos.2 and 3), however the tool wear mechanism remained generally similar, predominantly abrasive in nature, see Figure 3.17. Workpiece adhesion and adhesive wear processes were also identified by EPMA of a number of wear lands. The tool wear was similarly confined to the rougher tooth tips (Figure 3.18) and finisher tooth tip sides. Workpiece adhesion and gullet chip formations had also increased with the increase in cutting speed. Figures 3.19 and 3.20 show typical localised tooth tip workpiece adhesion or a built up edge (BUE). Failure of such an unstable BUE during metal cutting causes increased adhesive tool wear. Localised crater type wear was identified at the tool-chip contact points on the rougher and finisher rake faces. Typical workpiece gullet clogging is detailed in Figure 3.21.

Detailed SEM image of rougher tooth abrasive wear (Saw No.2) revealing fine ($\sim 1\mu\text{m}$) parallel surface scoring.

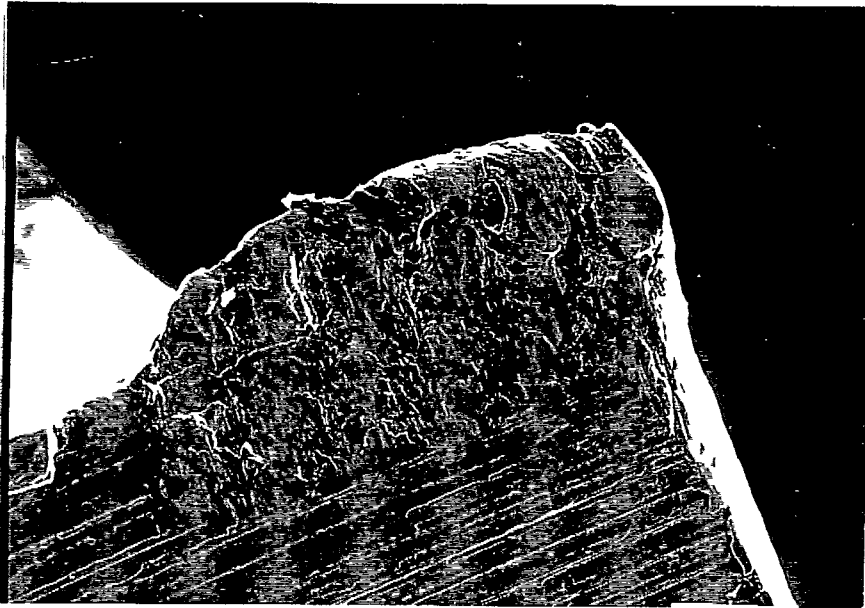
Figure 3.19

SEM image of a finisher tooth workpiece material BUE (Saw No.2) at the chip-tool contact point.

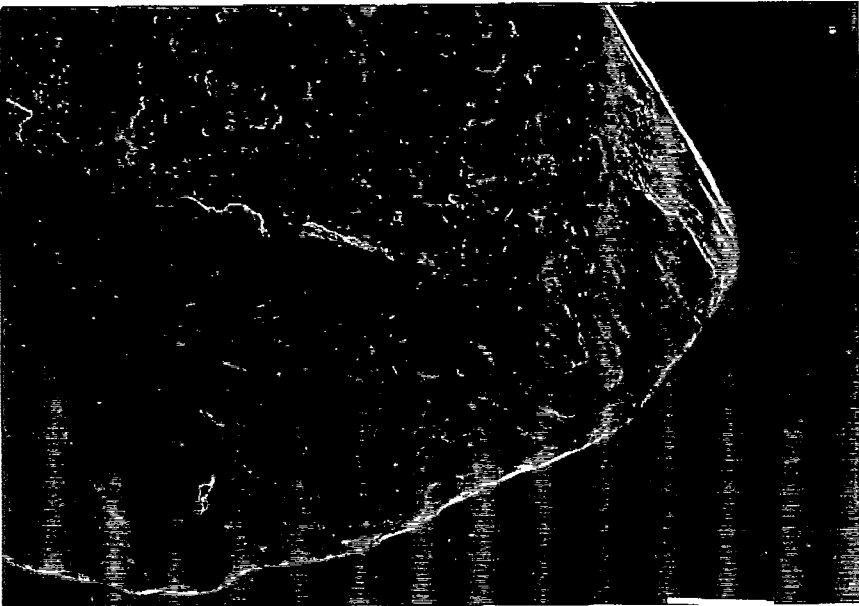
Figure 3.32

Detailed SEM image of the wear tested specimen shown above revealing microchippage, abrasive and adhesive wear.

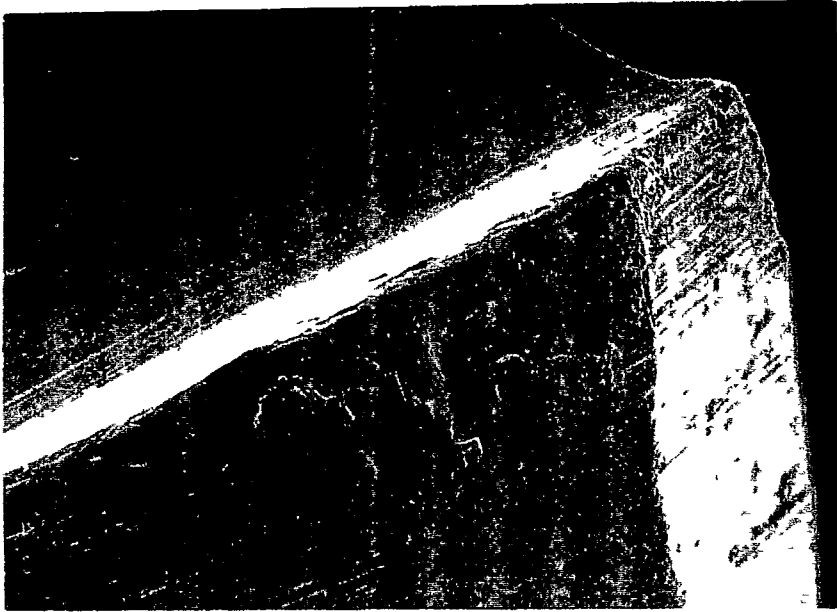
Figure 3.34

SEM image of a simulated wear tested rougher tooth detailing tooth tip abrasive and adhesive wear.

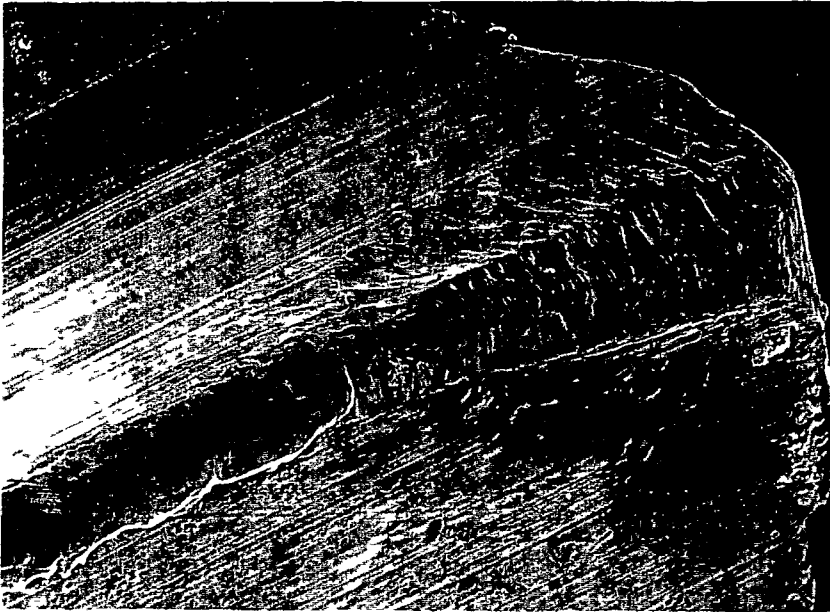
Figure 3.36

corresponded to the tool triple chip contact points (Figures 3.36 and 3.37).

SEM image of a simulated wear tested rougher tooth detailing rake face crater wear, tip blunting and clearance face abrasive wear.

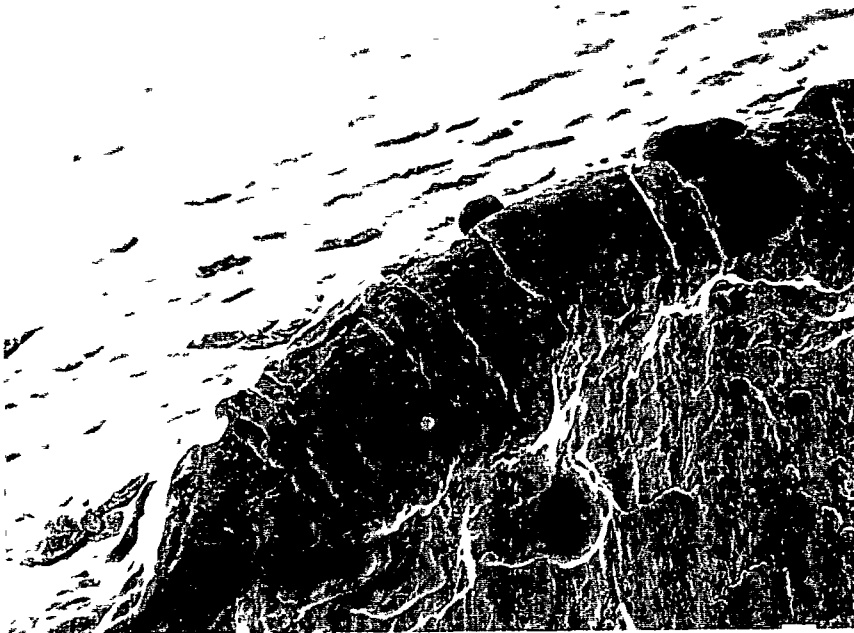
Figure 3.37

3.6.3 The formation of localised workpiece BUE's (Figure 3.38) at the chip tool contact points largely identical microstructurally to the BUEs identified on the wear tested product.

SEM image of a simulated wear tested finisher tooth tip side (18 m/min) detailing rake face crater wear and tip blunting (abrasive).

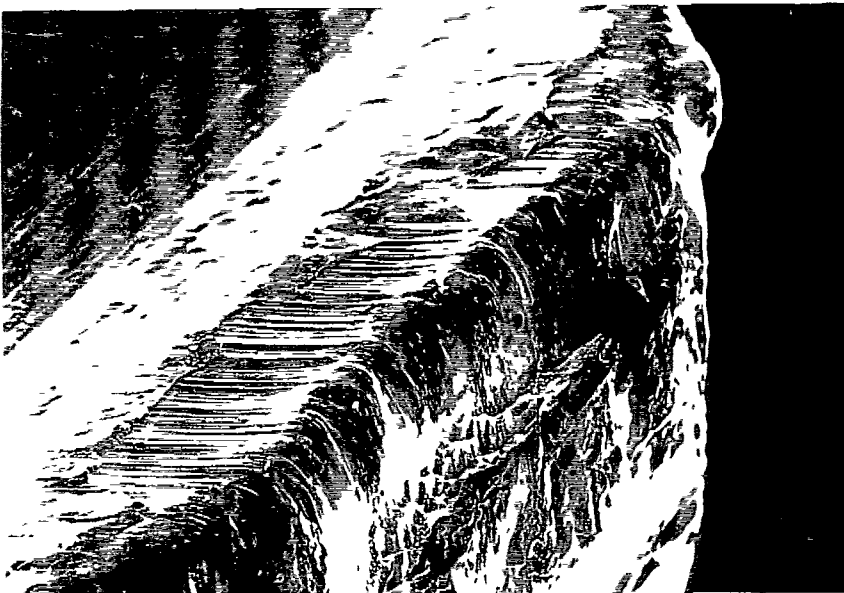
Figure 3.40

SEM image of a simulated wear tested finisher tooth detailing extensive side tip wear and workpiece material clogging.

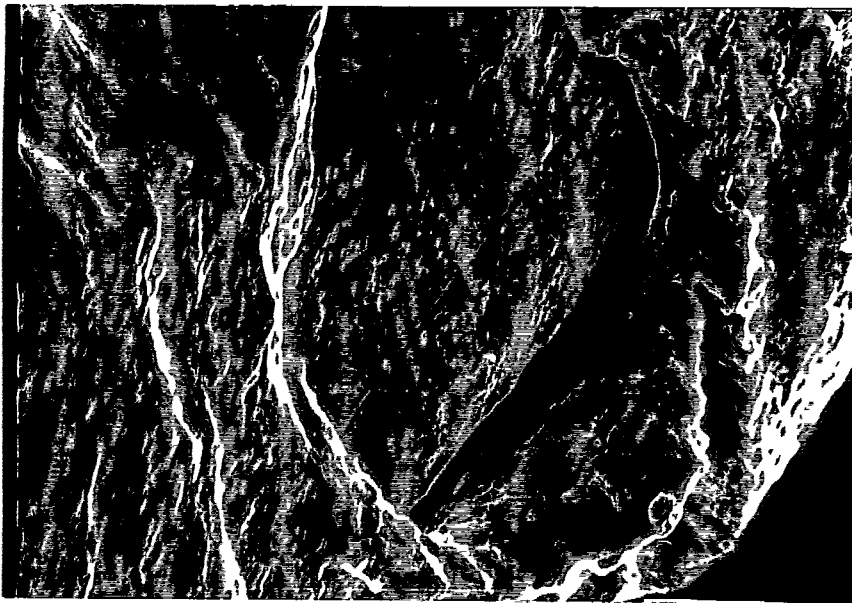
Figure 3.43

Detailed photomicrograph of the wear tested rougher (Figure 3.41) revealing numerous tooth tip rake face microcracks $<7\mu\text{m}$ traversing into the substrate.

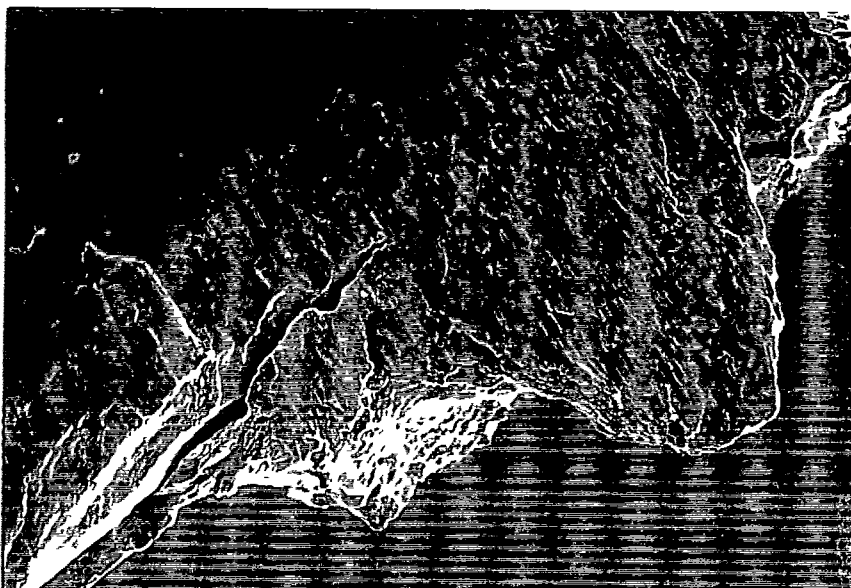
Figure 3.44

The identification of these surface microcracks was limited using SEM, due to extensive workpiece smearing on the tool wear lands. However parallel tooth tip microcracking was identified on a wear tested finisher tooth, (Figure 3.44) which appeared surrounded by adhered workpiece material. The materials were identified using EPMA (Plot 3.1). The cyclic surface stresses generated in intermittent metal cutting operations have been shown¹² to induce fatigue microcracking at the tool edge, largely identical to the features observed in the present work. However no indication of a discrete fatigue mechanism was identified, primarily due to subsequent wear and workpiece adhesion. The presence of these microcracks contribute to the development of tooth tip microchippage under the intermittent forces in metal cutting. Local failure of the finisher tooth BUE was observed (Figure 3.44), which was considered likely to result in adhesive wear of the tooth tip upon failure.

SEM of a wear tested finisher tooth (40 m/min) detailing a tooth tip microcrack traversing parallel with the cutting edge.

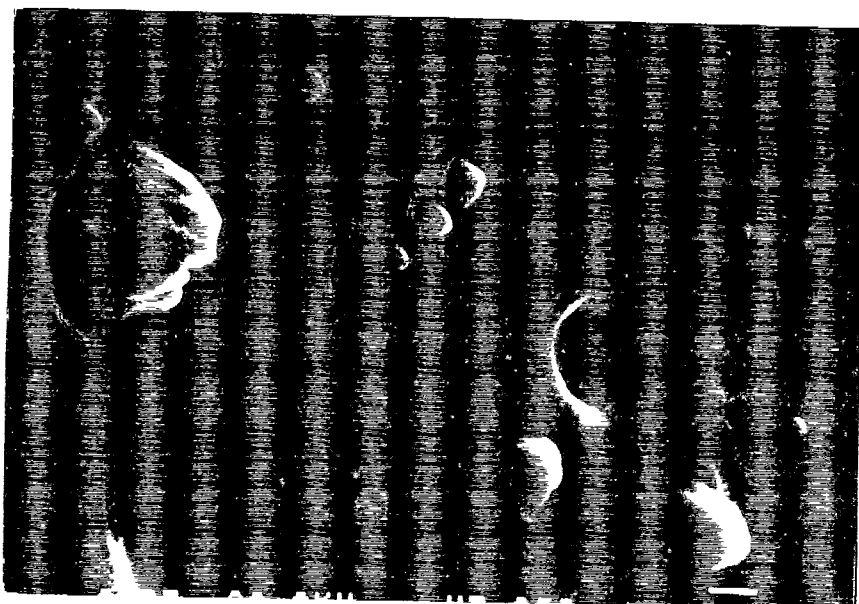
Figure 3.49

SEM image of a TiZrN film (magnetron sputtered) displaying coating cauliflower-like defects.

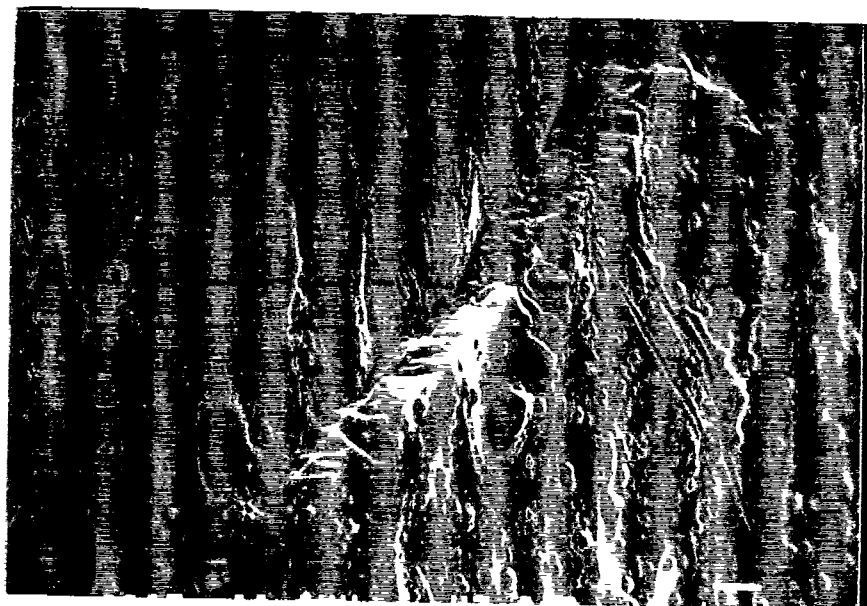
Figure 3.50

SEM image of a TiZrCN film (magnetron sputtered) detailing cohesive coating failure and a fine columnar structure morphology.

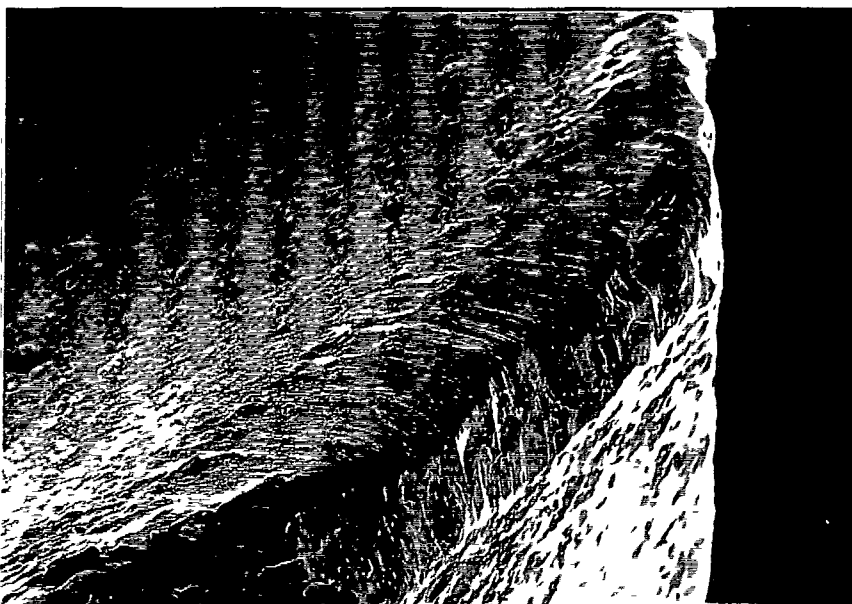
Figure 3.54

SEM image of a TiN coated rougher wear tested at 18 m/min under simulated conditions, displaying rake face crater wear and tip blunting.

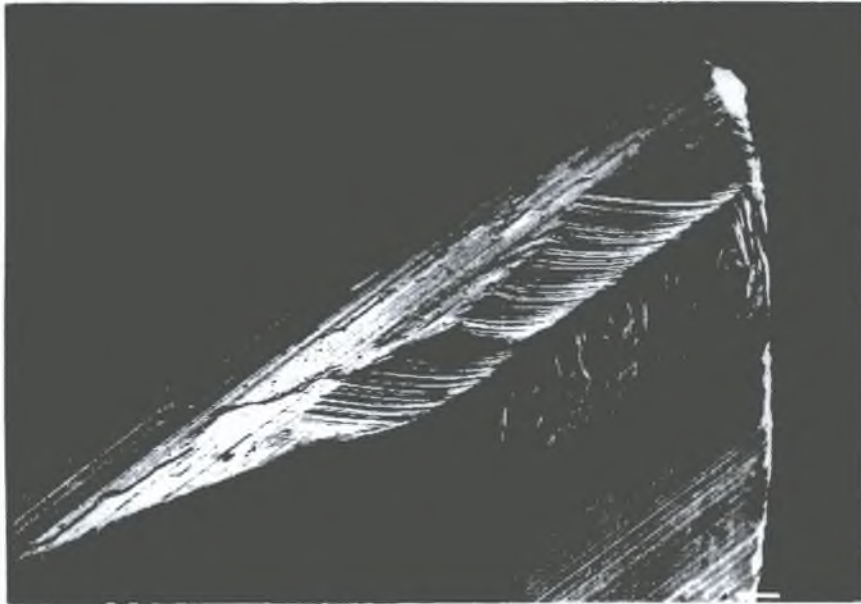
Figure 3.55

An increase in cutting speed from 18m/min to 40 m/min gave a marked reduction in E_{sp} during the wear testing of PVD coated circular saw single tooth specimens. The recorded reduction in E_{sp} over that of uncoated standard single tooth specimens occurred with significant changes in the tool wear modes. The control of PVD coated tool wear at 40 m/min cutting speed was identified to be directly related to the tool coating adhesion and thickness at the rake face tool-chip contact points. The suppression of the abrasive and adhesive wear which was indicative of the extensive workpiece material BUEs and gullet clogging among the uncoated circular saw single tooth specimens at slower cutting speeds, cf. Figure 3.38 and 3.39, are evident in Figures 3.55 and 3.56.

SEM image of a TiN coated wear tested (40 m/min) rougher tooth displaying rake face crater wear, tip blunting and clearance face wear by a mainly abrasive wear mode.

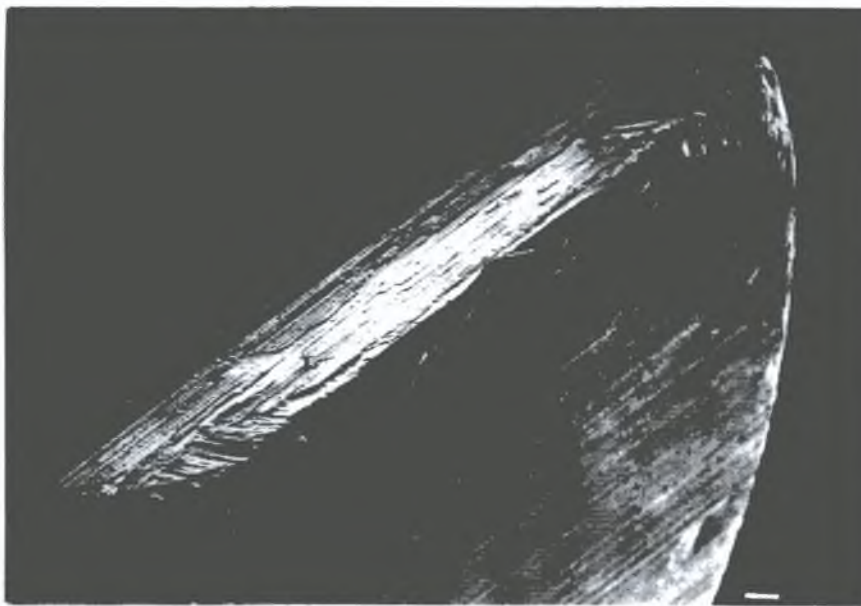
Figure 3.56

These film microcracks were observed to propagate into the adjacent surface carbides, but were blunted by the martensitic matrix. The film-substrate adhesion appeared excellent despite the numerous microcracks. A comparison of the rake face crater wear (specimen BT03) noted earlier (Figure 3.56), and the absence of crater wear (specimen BW01) shown in Figure 3.66, indicates the potential of arc evaporated PVD coatings.

SEM image of a TiN coated wear tested (40 m/min) finisher tooth displaying rake face crater wear and tooth tip blunting.

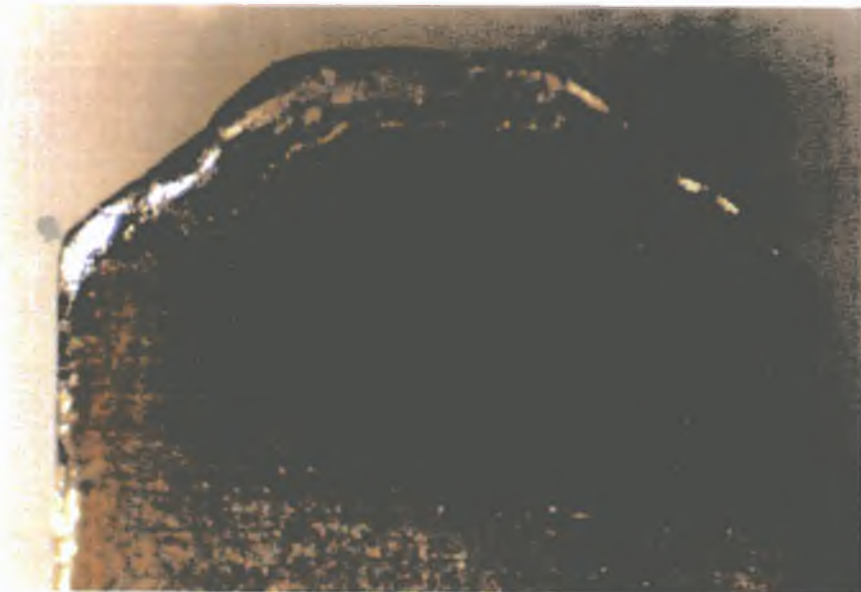
The overall PVD coated tool geometries were largely maintained with three dominant wear mechanisms in evidence, namely rake face crater wear (predominately abrasive), tooth tip rounding wear (abrasive) and localised tooth tip microchipping. Figure 3.57 illustrates the extent of the rake face crater wear observed on a TiN coated specimen wear tested at 40 m/min. The suppression of workpiece adhesion which was confined locally on the wear lands was widely observed using SEM. Examination of an untested TiN coated rougher tooth from the same deposition run displayed local coating decohesion on the rake face, largely corresponding to the tool chip contact zone. Following subsequent wear testing rake face crater wear developed unhindered on the exposed rake face. Identical wear mechanisms were observed with both TiAlN and TiAlVN (arc evaporated - (Aachen), see Figures 3.58 and 3.59. In this case the coating thickness ($<0.5\mu\text{m}$) at the tooth chip contact points was insufficient to prevent the onset of crater wear.

Photographic overview of the characteristic rake face chip contact abrasive crater wear formed during a wear test at 40 m/min.

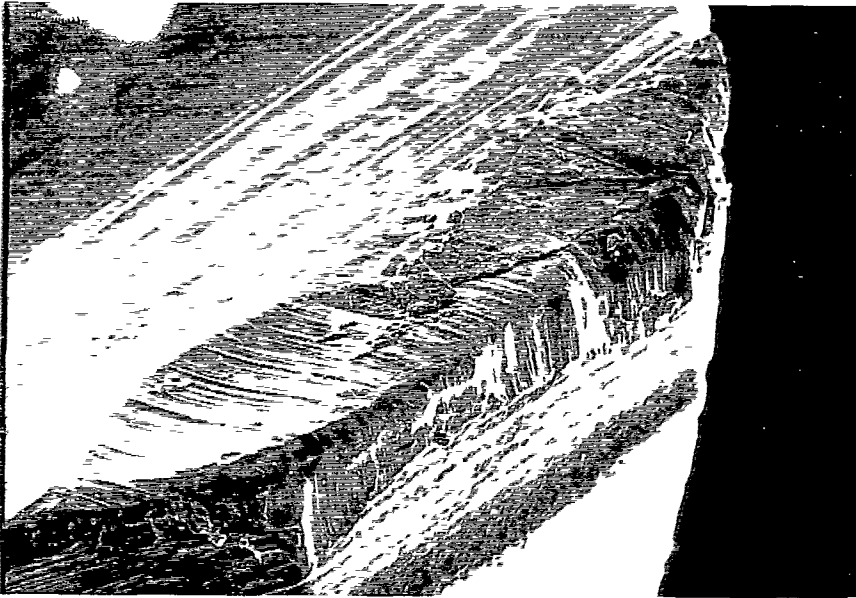
Figure 3.58

SEM image of a TiAlVN coated rougher tooth wear tested at 40 m/min displaying discrete rake face crater wear at the chip contact point.

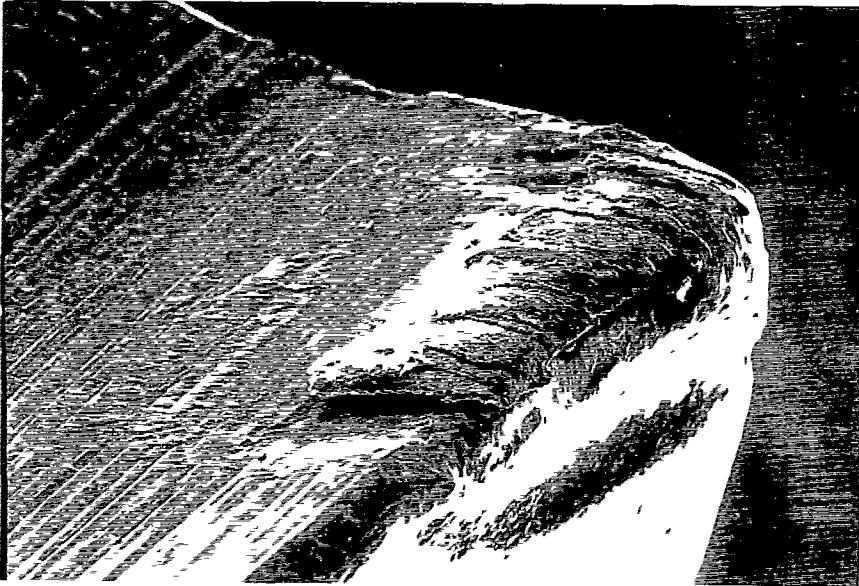
Figure 3.59

SEM image of a TiAlVN coated finisher tooth detailing workpiece adhesion at the tool chip contact point.

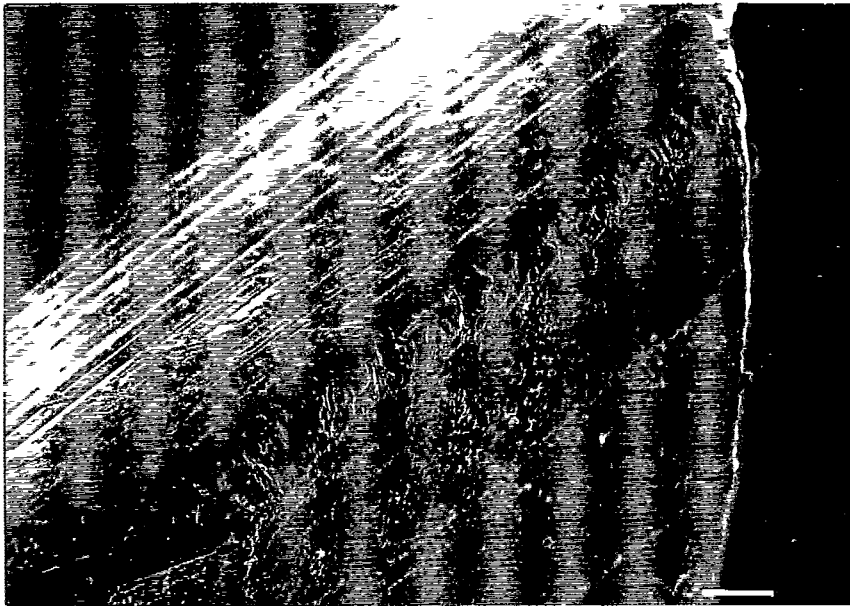
Figure 3.61

A virtual suppression of rake face crater wear was obtained with an arc evaporated TiN coating (designated BW01) supplied by Balzer. The rougher and finisher teeth wear tested at 40 m/min are shown in Figures 3.61 and 3.62 respectively. In this instance the coating integrity was sustained on the rake face up to the tooth tip with only localised abrasive wear and microchipping observed using SEM. Microcracks were identified on specimen BW01 at the worn tooth tip (exposed substrate). These microcracks were observed running parallel to the cutting edge (Figures 3.63 and 3.64). No indication of a fatigue mechanism was discerned on the surface of the resultant craters, which in each instant had been worn, by a mainly abrasive mode, resulting in an uneven wear pattern along the tool cutting edge. A microsection of the finisher tooth is shown in Figure 3.65. Localised tooth tip wear and workpiece adhesion is evidenced by the absence of the TiN film (1.5-2.0 μ m thick). Rake face TiN microcracking was identified (inset photomicrograph Figure 3.65) as a series of microcracks running perpendicular to film surface.

SEM image of a TiN coated (Balzer) rougher tooth detailing localised tooth tip microchippage and abrasive wear.

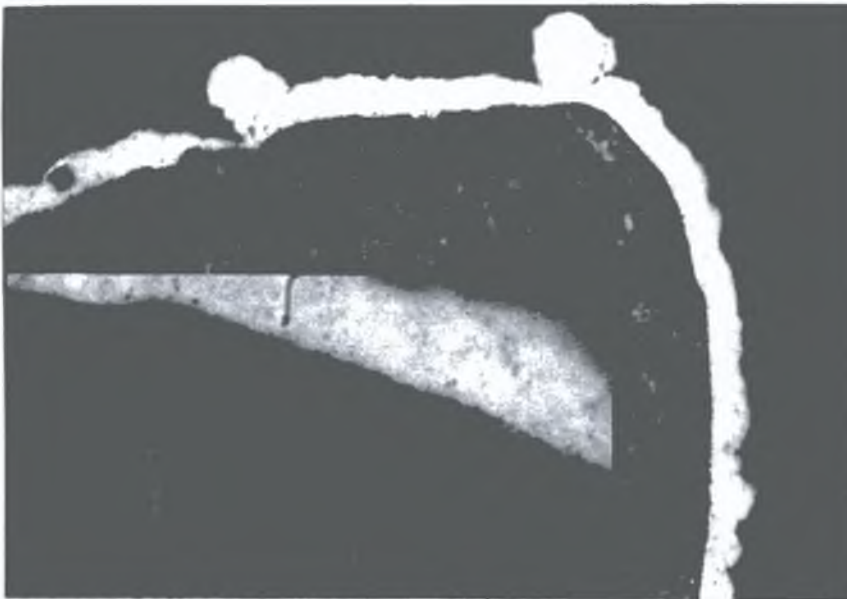
Figure 3.65

Photomicrograph of the TiN coated rougher detailed in Figures 4.62 and 4.63 detailing workpiece adhesion and cracking (tip) and rake face TiN microcracking (Inset X 1500).

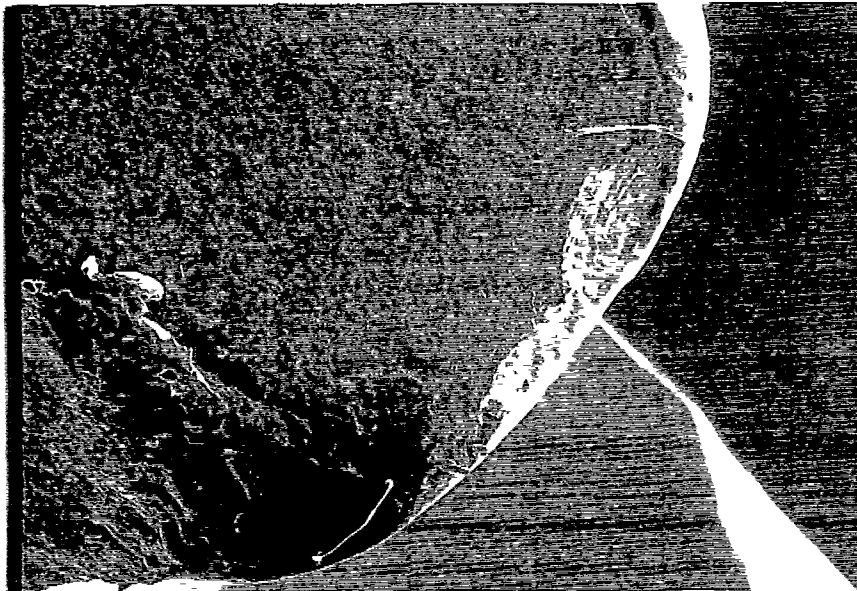
Figure 3.68

During wear testing⁴⁶ the TiN coated H13 specimens gave very high E_{sp} during the test, and failed after five cuts. Examination of the wear tested specimen revealed substrate deformation due to the metal cutting forces. Extensive microchipping and plastic deformation was noted via optical microscopy. Metallography revealed plastic deformation and thermal softening of the underlying substrate. Coating failure had occurred as a result of substrate deformation.

SEM image of a wear tested 18 m/min TiN coated finisher (H13 substrate material) displaying substrate microchippage

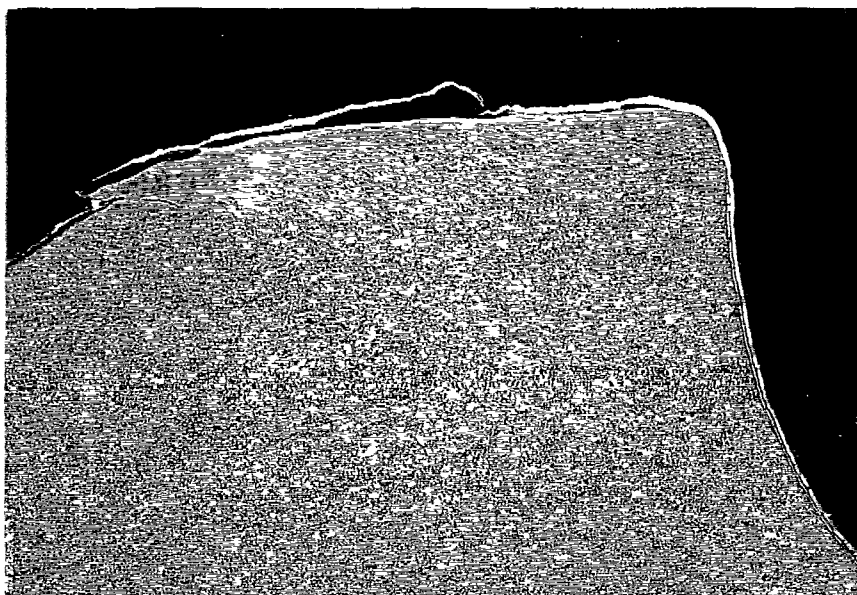
Figure 3.69

Photomicrograph of the wear tested rougher detailed in Figure 3.68 revealing plastic deformation of the H13 substrate.

The photomicrographs of the wear tested tools illustrate both workpiece adhesion (darker etched) and substrate plastic deformation (Figures 3.69 and 3.70). It should be noted that the outer white layer is a Ni coating deposited prior to specimen preparation for metallography. This additional layer served to provide edge retention during polishing, see section 2.3.4.

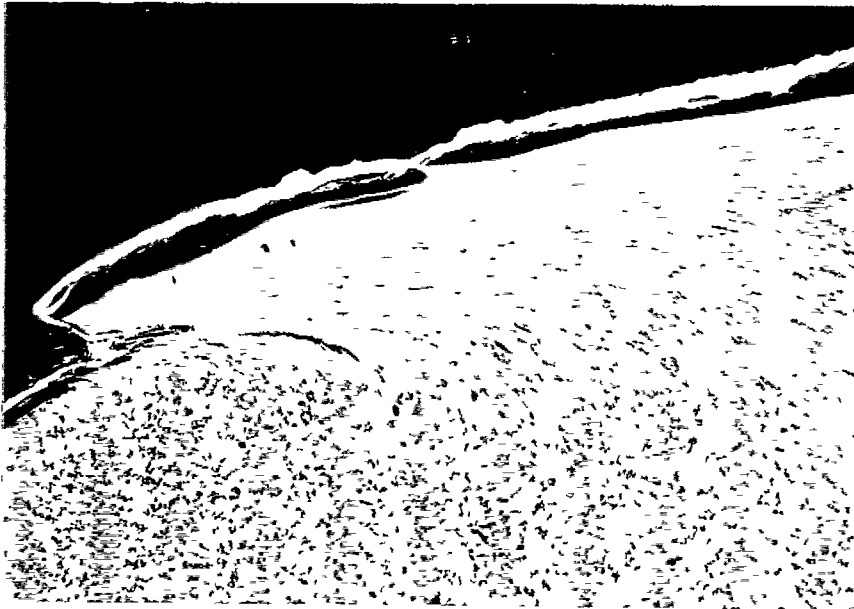
Figure 3.70

Detailed photomicrograph of the substrate detailed in Figure 3.69 revealing an unetch white zone indicative of reaustenisation.

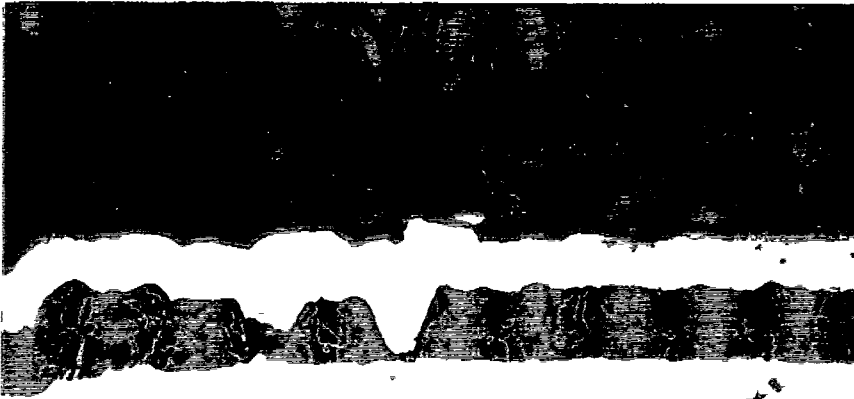
Figure 3.73

Microstructural and SEM morphological examinations of the coated bandsaw single tooth specimens identified poor geometrical thickness uniformity, cauliflower-like defects which in many instances had become dislodged (Figure 3.72-3.73) and local film delamination (Figure 3.74). The chemical composition of the inclusion (Figure 3.72) was different to that of the underlying bulk film. This chemical difference can result in different thermal expansion properties and can ultimately lead, upon thermal cycling, dislodgement of the cauliflower defect from its anchorage to the bulk film. This results in a valley in the film, which in many instances has a depth equal to the film thickness. This provides an avenue for (a) corrosion attack; (b) an accumulation of wear debris and (c) ultimate local film failure of the coating during wear testing.

Photomicrograph of a sputtered TiAlVN film displaying a coating pinhole defect.

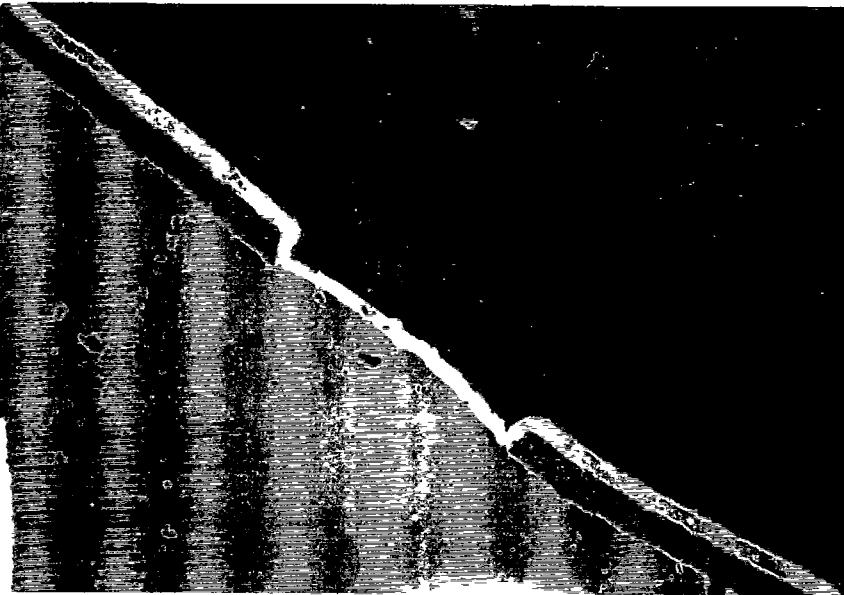
Figure 3.74

Photomicrograph of a sputtered TiAlVN film displaying bandsaw rake face film delamination.

Following careful consideration of the sputter film defects, and the difficulties encountered in obtaining uniformity of film thickness, it was recommended⁴⁴ that sputter coatings should no longer be pursued as a surface engineering route for bandsaw

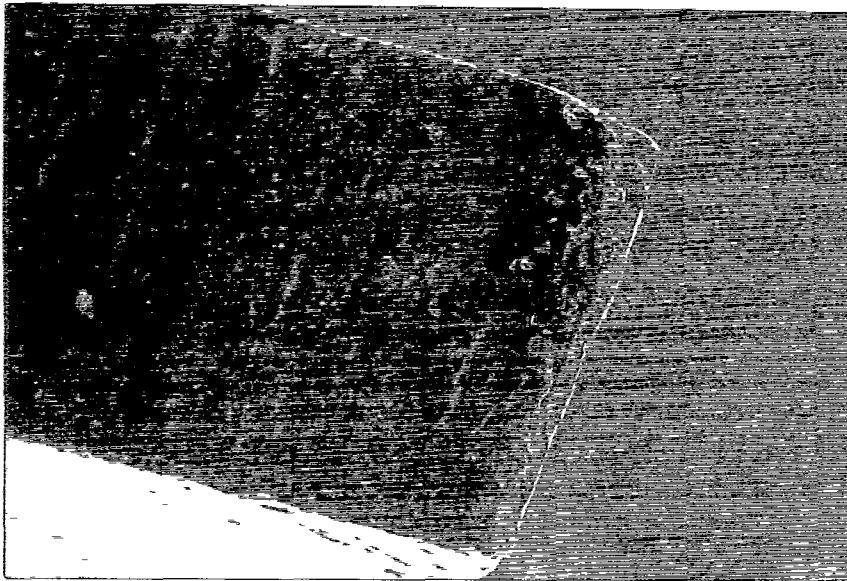
Figure 3.77

SEM of a TiN coated bandsaw single tooth specimen detailing localised tip microchipping and abrasive wear.

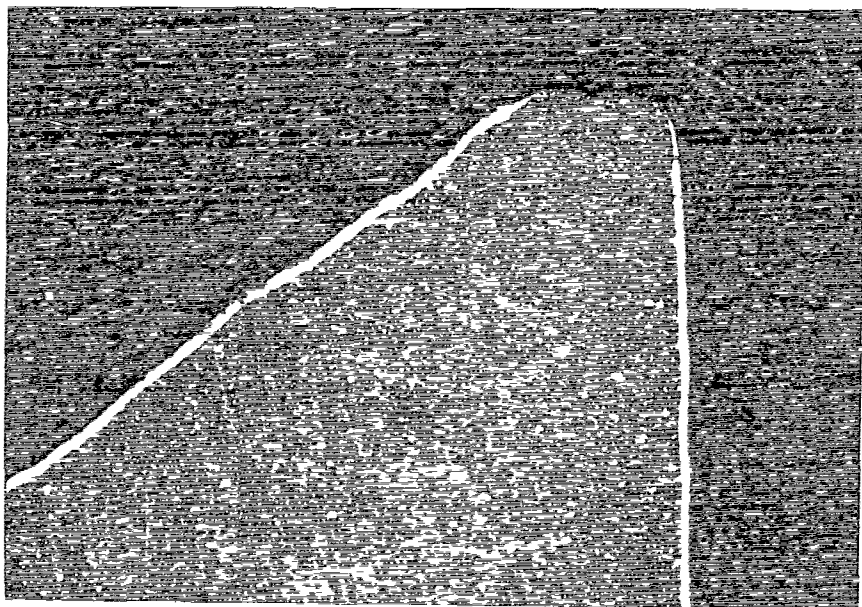
Figure 3.79

Metallography revealed no coating defects as had been observed with the magnetron sputtered coatings. Examination of untested specimens from each coating batch showed good coating thickness uniformity. The TiN coatings were 4-5 μ m (Figure 3.79) whereas the TiCrN coatings were <1.5 μ m thick. The accentuated tool wear noted in the TiCrN specimens was attributed to insufficient coating thickness. In addition the presence of tooth tip burrs was considered as a likely route to coating failure at the tooth tip, initiating at the very start of the wear test.

Photomicrograph of a typical TiN coated bandsaw single tooth specimen detailing coating failure and wear at the tooth tip.

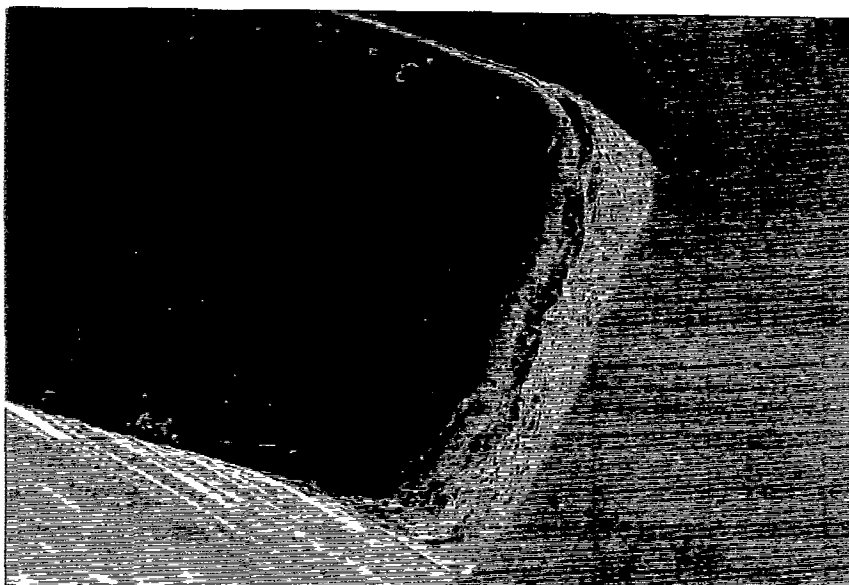
Figure 3.80

Two arc coatings namely TiN and TiCrN were applied to bandsaw single tooth specimens and wear tested at 59 m/min. The dominant wear modes remained abrasive and adhesive, once coating degradation had occurred. However, suppression of tool adhesive wear by the presence of the coating on the rake face was identified. TiN coating uniformity was good, with the film degradation at the tooth tip wear land observed. Detailed examination of the tool rake face corresponding to the tool chip contact zone revealed localised film delamination. The dominant TiN coated bandsaw single tooth sample wear modes are illustrated in Figures 3.75-3.79. The TiCrN coated bandsaw single tooth specimens displayed similar wear modes. However tooth tip transformation was identified in a number of specimens. Examination of the rake face chip tool contact zone revealed local film delamination and smearing. Workpiece adhesion was confined to the tooth tip wear land, with negligible gullet polishing. Figures 3.80-3.84 illustrate the characteristic TiCrN bandsaw wear modes which were observed.

SEM image of a TiCrN coated bandsaw single tooth specimen wear tested at 18 m/min detailing tip workpiece adhesion.

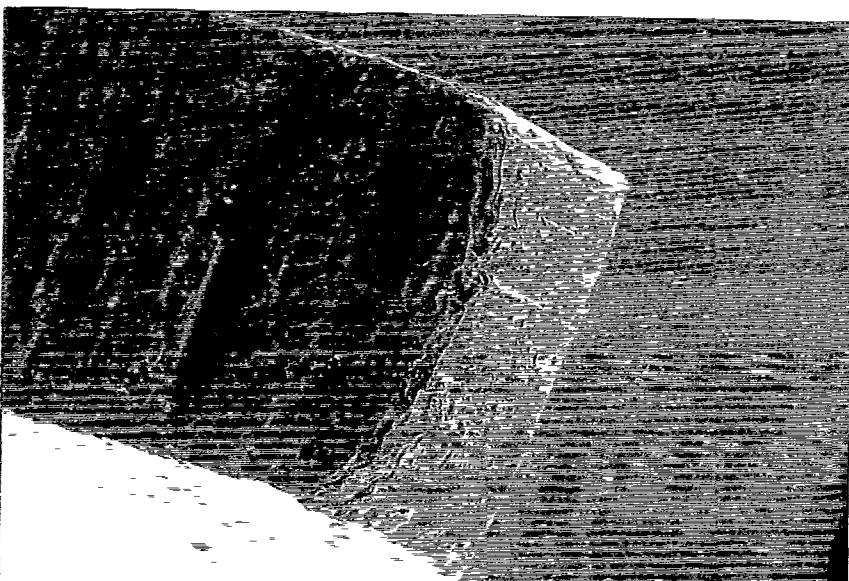
Figure 3.81

SEM image of a TiCrN coated bandsaw single tooth specimen detailing abrasive and adhesive wear.

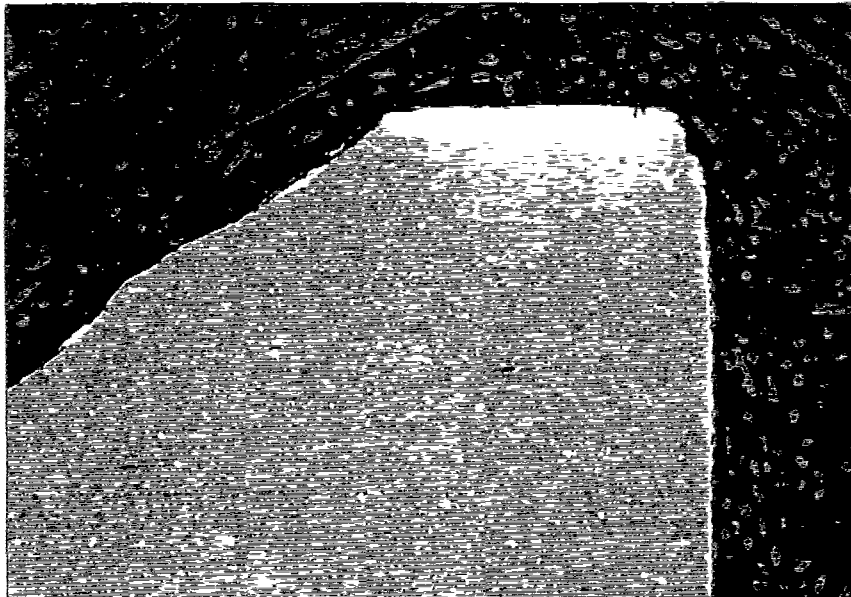
Figure 3.83

Photomicrograph of a wear tested TiCrN coated bandsaw ($<1\mu\text{m}$) displaying tooth tip reaustenisation

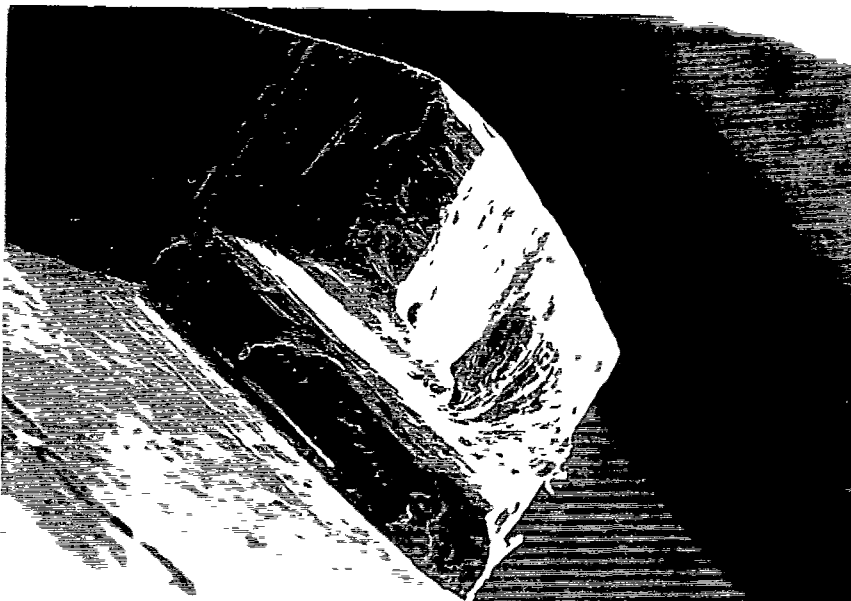
The characteristic tool wear and failure modes observed among both TiN and TiCrN coated bandsaw single tooth specimens are shown in Figures 3.84-3.90. This side tip wear is evident in Figure 3.84 as a concave wear gouge. The wear was observed on a number of specimens, with largely identical orientation. Metallography revealed a distinct etch-resistant band within the HSS, consistent with the side tooth tip wear. The band was indicative of a re-austenised zone, consistent with temperatures required for plastic deformation, (Figure 3.86).

The incidence of the severe side tip wear was attributed to the onset of tertiary wear as the tool reached the end of the wear test. However, the remaining evidence suggests that abrasive and adhesive wear are the steady state wear modes at these elevated cutting speeds. In a number of instances side tip protection was obtained by the presence of a hard coating $>5\mu\text{m}$ in thickness. However, the specimens examined were subjected to full wear tests

SEM image of a TiN coated bandsaw wear tested at 110 m/min, detailing extensive side tip wear and plastic deformation.

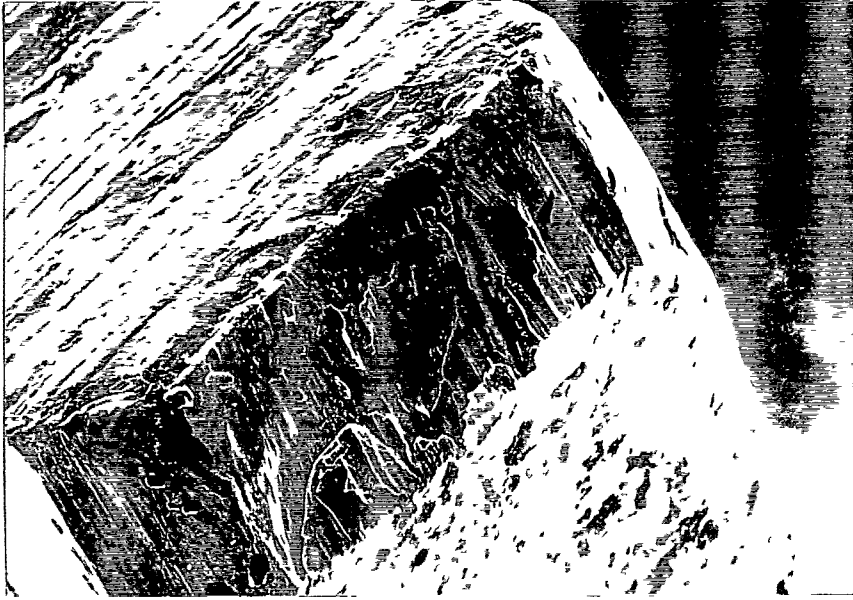
Figure 3.85

Detailed image of the tooth tip wear land (Figure 3.84) detailing abrasive and adhesive wear.

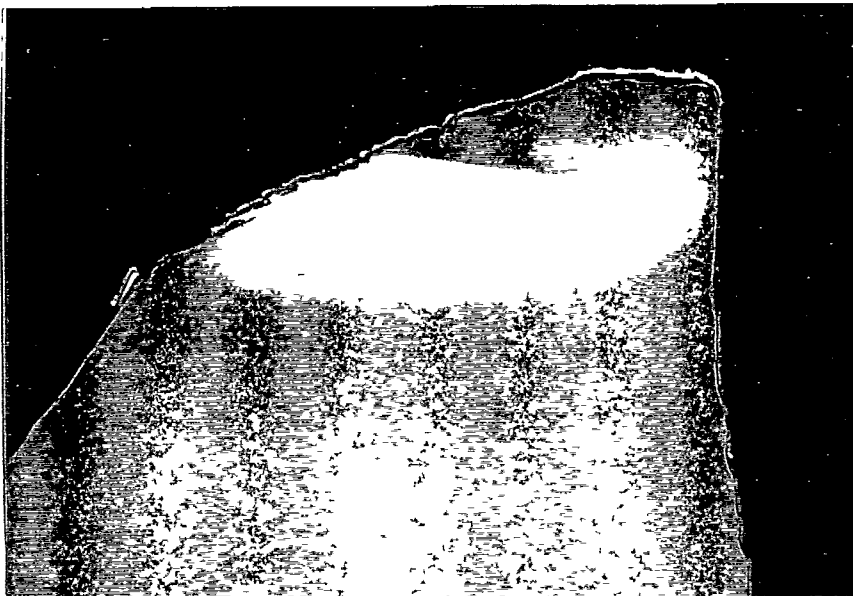
Figure 3.86

Photomicrograph of the bandsaw single tooth specimen detailed above revealing a re-austenitised band consistent with the tooth side wear.

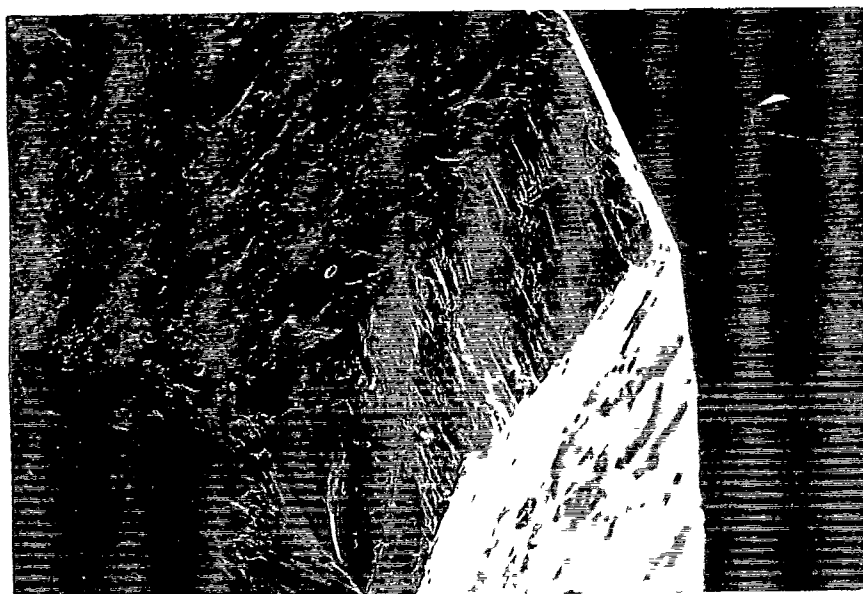
Figure 3.87

SEM image of a TiN coated bandsaw single tooth specimen wear tested at 110 m/min displaying tip abrasive and adhesion wear.

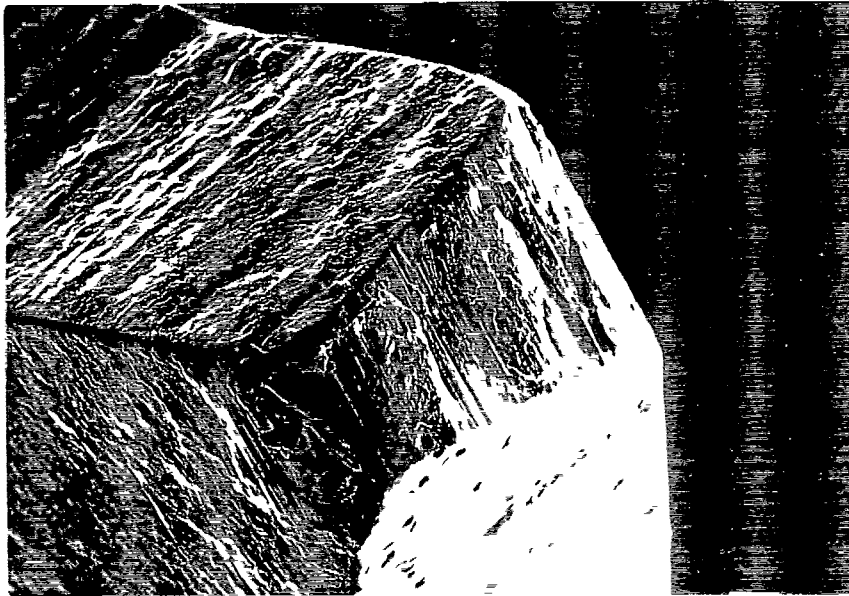
Figure 3.88

SEM image of a TiCrN coated bandsaw single tooth specimen wear tested at 110 m/min detailing tip abrasive and adhesive wear.

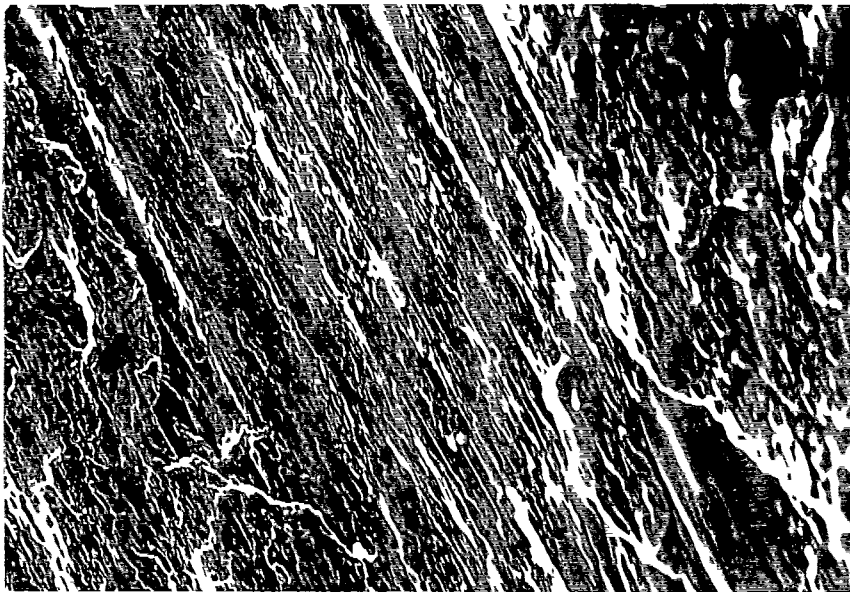
Figure 3.89

Detailed SEM image of the tooth tip wear land shown above confirming abrasive and adhesive wear as the main wear modes at 110 m/min.

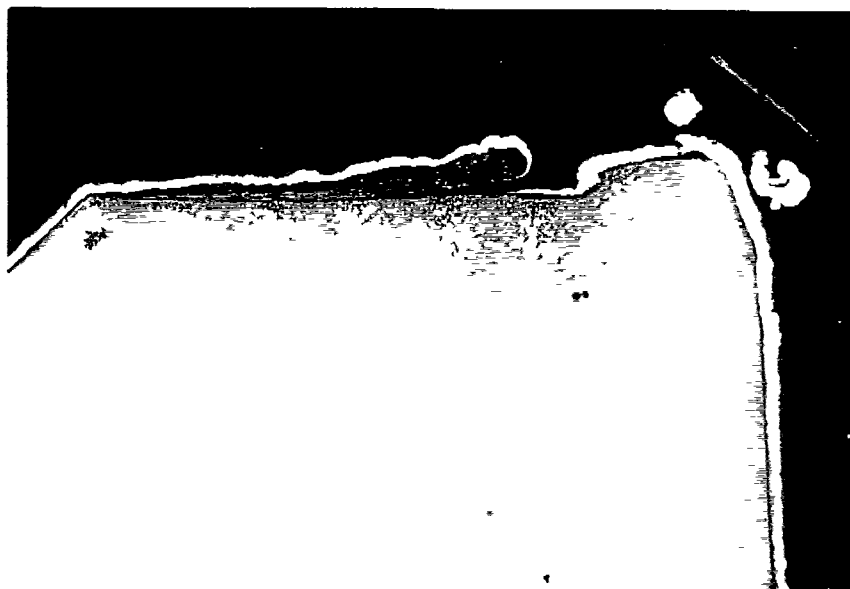
Figure 3.90

Photomicrograph detailing workpiece adhesion at the tooth tip wear land and local overtempering of the HSS (darker etched).
